**AN INVESTIGATION OF DRIVELINE INCIDENTS OF
THE US ARMY'S MODEL M1078 LIGHT MEDIUM
TACTICAL VEHICLE (LMTV)**

**US ARMY TANK-AUTOMOTIVE AND ARMAMENTS
COMMAND (TACOM)**

CONTRACT NUMBER:
DAAE07-98-C-M012

ENGINEERING REPORT

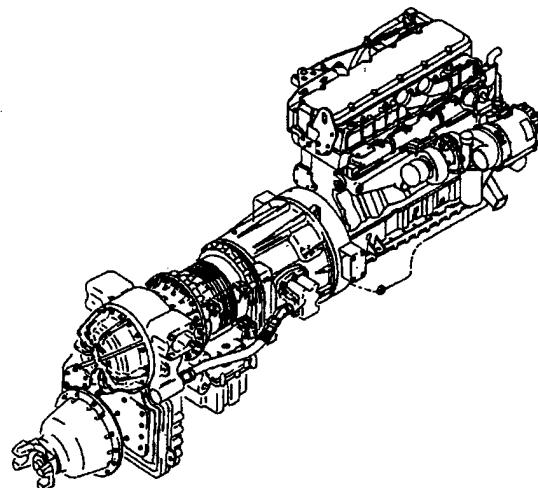
- 1) **Powerpack vertical bending:** The powerpack vertical bending resonant frequency is lower than a normal powerpack. The low frequency is primarily a result of an integral transmission/transfer case configuration joined to an engine of about equal mass by a relatively elastic flywheel housing (see figure 2.1). This results in a vertical bending resonant frequency of 43 to 48 Hz which corresponds to a 1st order driveshaft speed equivalent to about 44 to 49 mph road speed, a very common operating speed. Also, the same resonant response is excited at level road maximum vehicle speed (55 to 58 mph) by components rotating at engine speed.

Figure 2.1 Illustration of powerpack configuration

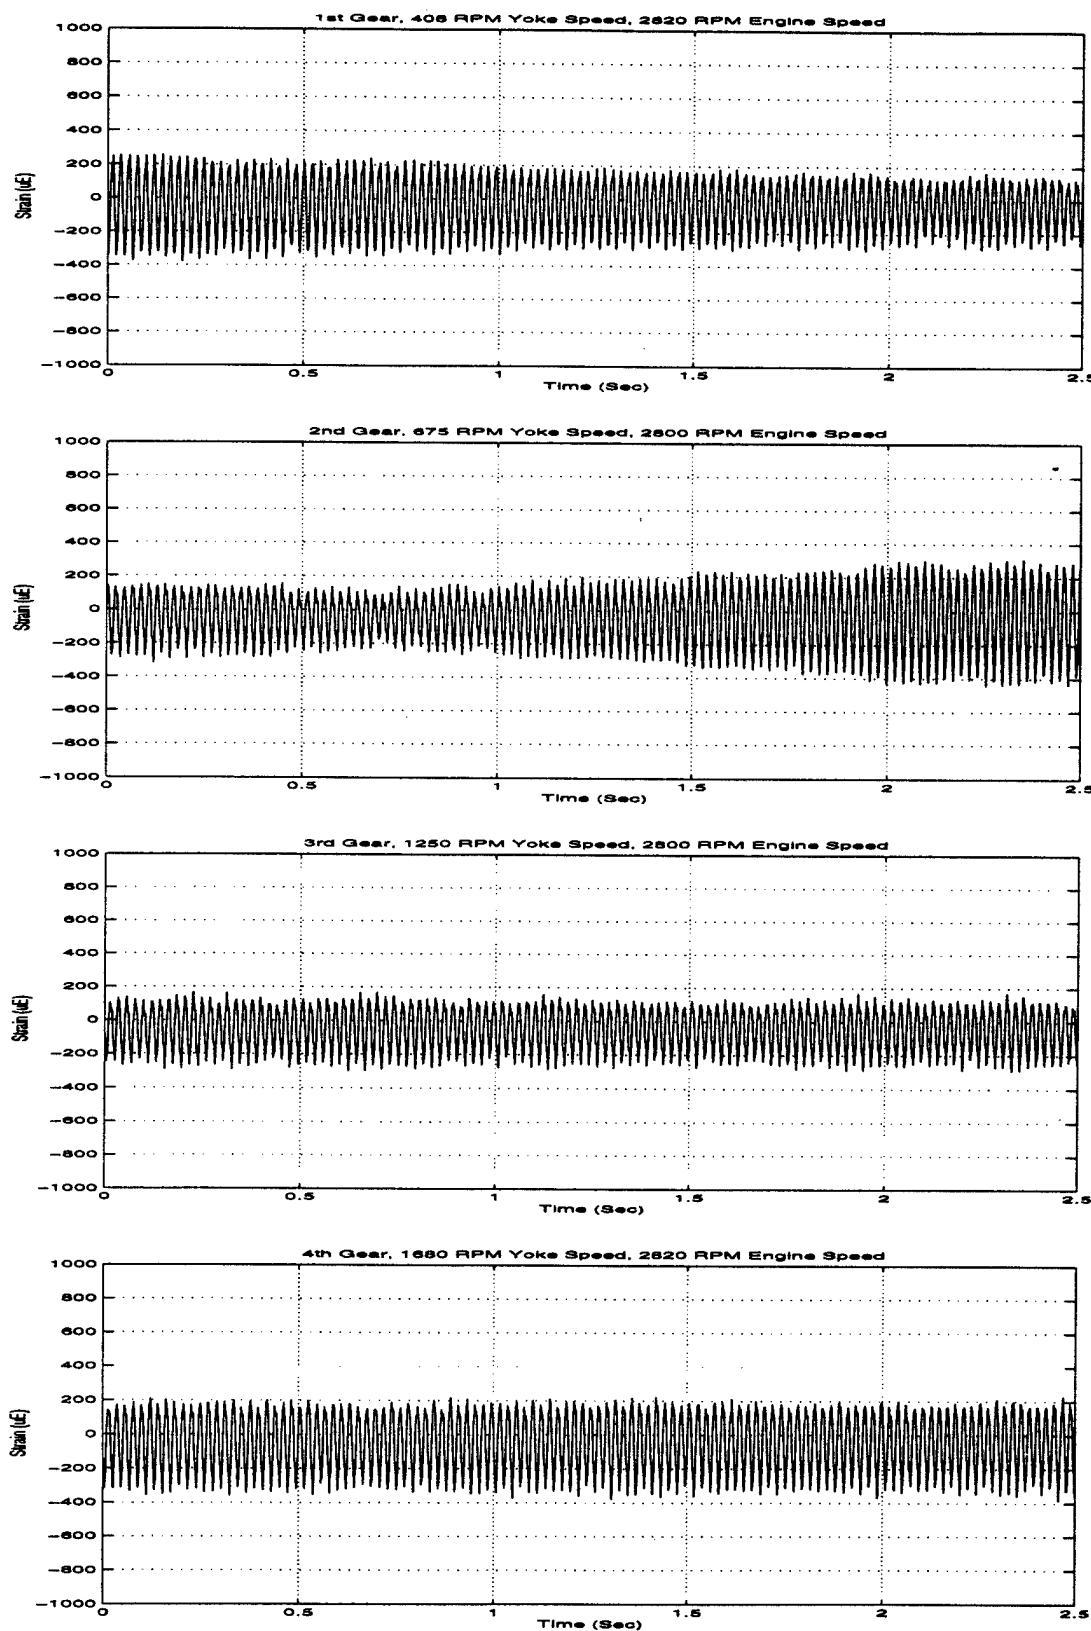
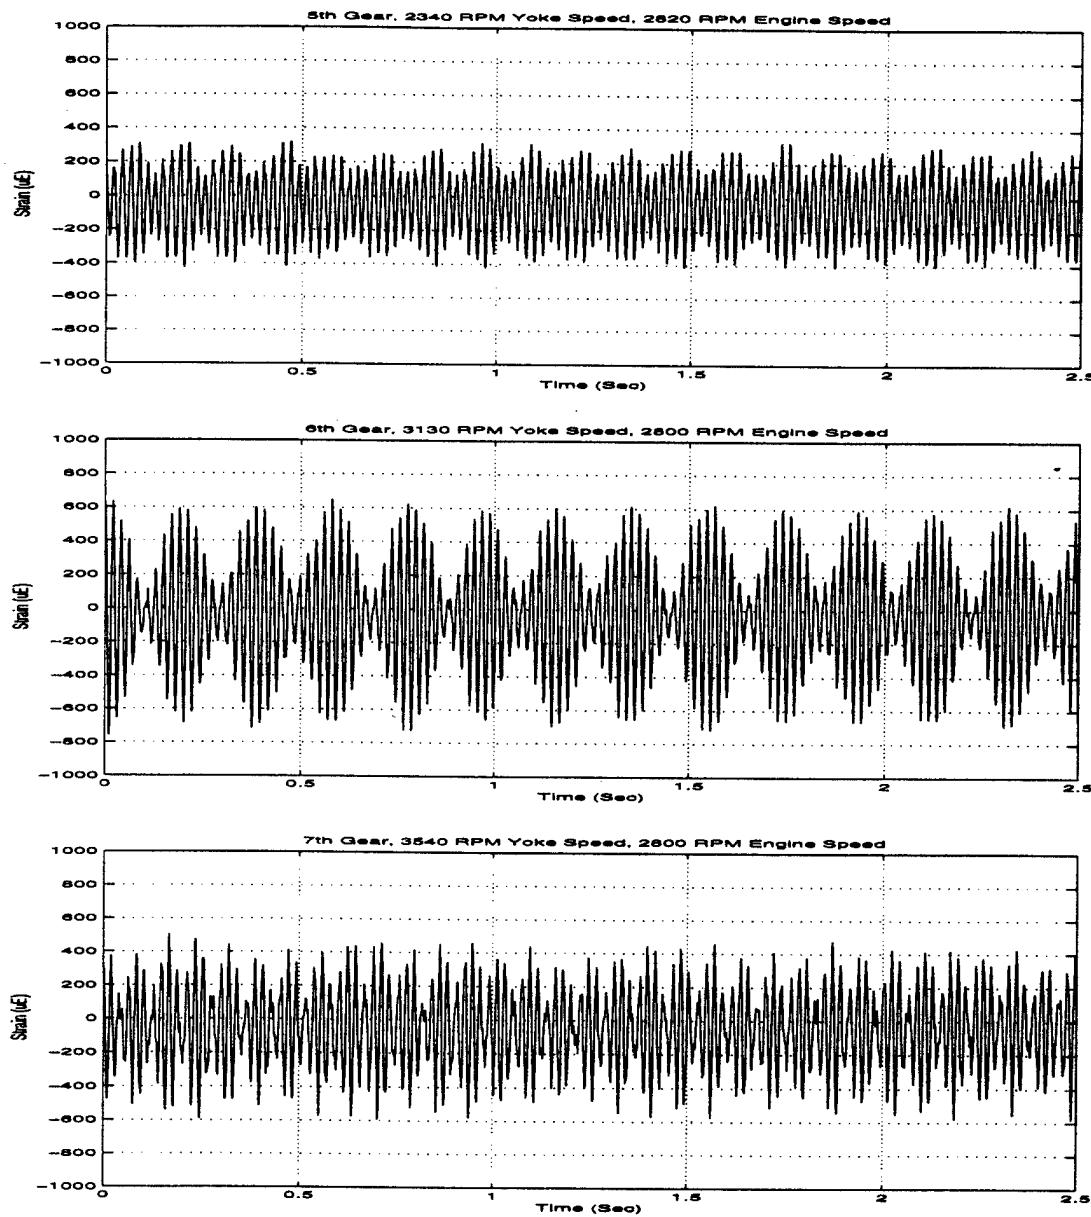
It is important to note that the powerpack configuration is sensitive to two excitors of differing frequencies: i) the driveshaft and/or components rotating with the driveshaft and ii) the engine/transmission. In seventh gear the engine rotates at 78 percent of the driveshaft speed. In sixth gear the engine rotates at 90 percent driveshaft speed. Figure 2.2 are time history plots of strain at GAGE #1 in gears one through seven (see figure 2.3 for the location of GAGE #1). All of these plots are with *no driveshafts installed*. The plots therefore demonstrate the sensitivity of the powerpack to excitement from components inside the transfer case (including the yokes) that rotate at driveshaft speed. The sixth gear plot clearly shows the presence of both exciting frequencies as indicated by the beating that modulates the amplitude of flywheel housing strain by nearly 100 percent. This amount of modulation implies that the two excitors (in this case transfer case components and engine/transmission components) are nearly equal *in their effect*, i.e. they can be of different magnitudes but affect the system differently because they act at locations of differing sensitivities or driving point mobilities. Figure 2.4 shows a comparison of the two excitors (again, transfer case components and engine/transmission components) in a waterfall plot format during sixth gear operation.

Figure 2.2 Flywheel housing strain at "GAGE #1 as excited by both the transfer case driveshaft components and the engine/transmission components (no driveshafts installed)

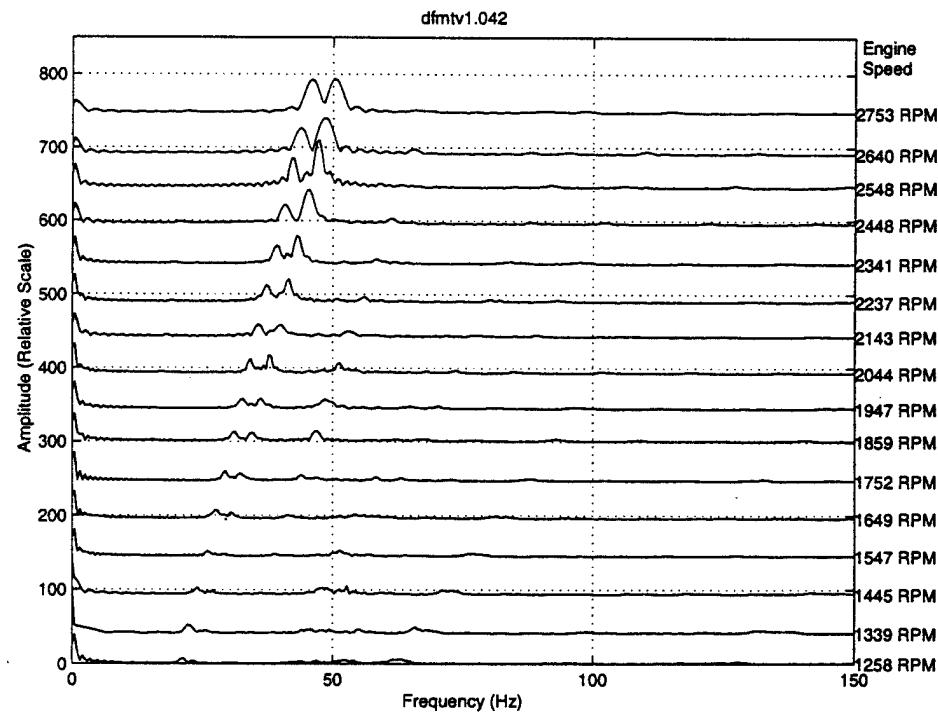
Figure 2.4 Waterfall plot showing relative amplitudes of engine/transmission and driveshaft excitation frequencies during an engine speed sweep in 6th gear (no driveshafts installed)

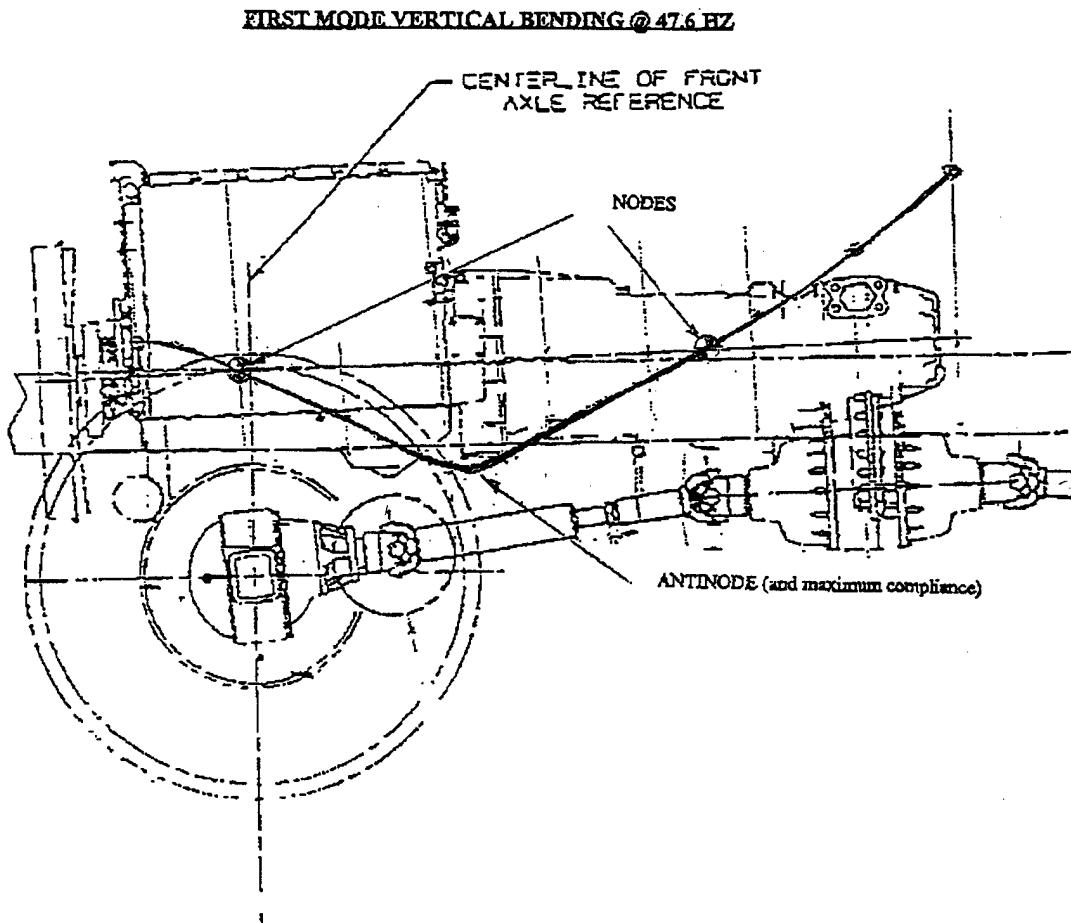
- 4) The operating bending mode shape of the powerpack (see figure 4.3) was obtained by holding the output speed constant at the speed of maximum response and probing the vertical motion of the powerpack with a vibrometer at increments along the length of the powerpack. The plot in figure 4.3 represents the in-phase component of the results. This test was performed with the original production flywheel housing installed. The same test was repeated with a Michigan Scientific nodular iron flywheel housing and did not produce comparable results because the 43 to 48 Hz vertical bending resonant peak was no longer attainable, being replaced by a predominantly lateral bending mode at about 65 Hz.

Figure 4.3 Bending mode shape of powerpack

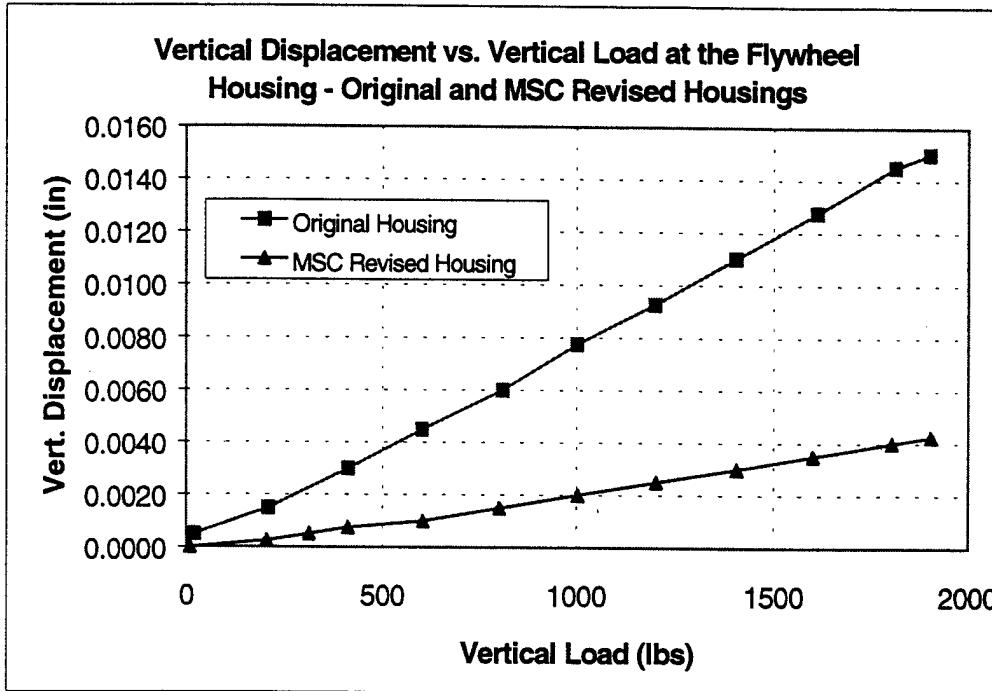
- 6) The results of bending stiffness measurements comparing the original flywheel housing to the MSC revised design nodular iron flywheel housing are shown in figure 4.4. The measurements were made by suspending a rigid steel bar from the powerpack and using a dial indicator to measure deflections as a vertical force was applied to the powerpack at the flywheel housing. Similar methods were used in the lateral direction to obtain data for use in the computer model of the powertrain.

Figure 4.4 Comparison of flywheel housing stiffnesses, original vs MSC versions

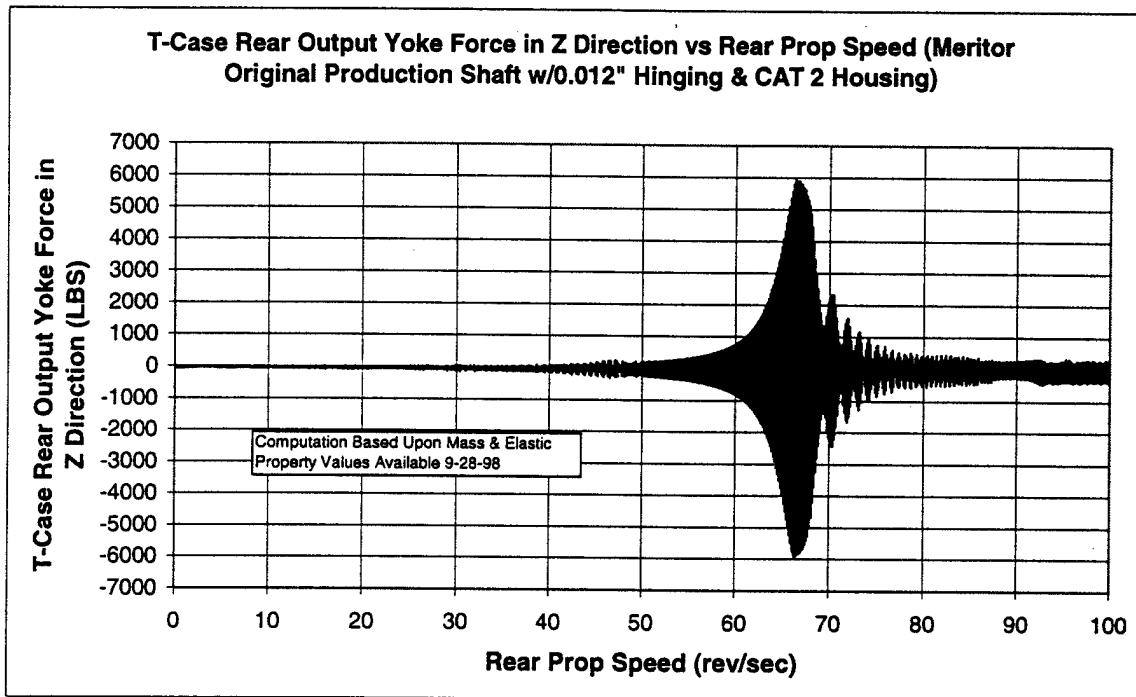
In the MSC DADS model the Meritor original production driveshaft was modeled by dividing the driveshaft into six bodies. These six bodies were connected by a total of five bushing elements and the appropriate stiffness entered for each bushing. The complete driveshaft assembly was then connected by universal joints to the transfer case rear output yoke and the rear axle input pinion yoke. As noted above, the model results indicated a 1st mode bending frequency of 66 to 67 Hz, see figure 5.5.

Figure 5.5 MSC DADS model output of Meritor original production driveshaft

The deflection of the driveshaft induces large centrifugal loads on the U-joints. The front U-joint forces are transmitted to the transfer case and act as an exciter to the powerpack bending vibration.

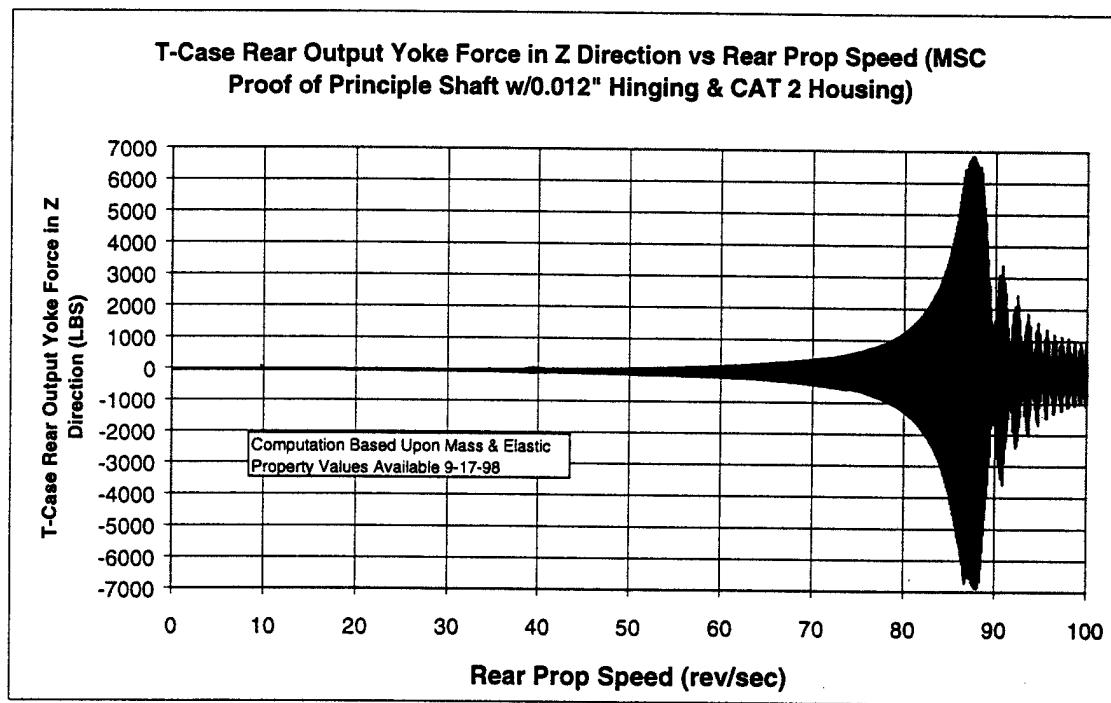
Figure 5.7 MSC DADS model output of MSC proof of principle driveshaft

Note that the resonant frequency is shown to have increased to 87-88 Hz. Clearly, it was found that increasing the spline bending stiffness would be extremely beneficial.

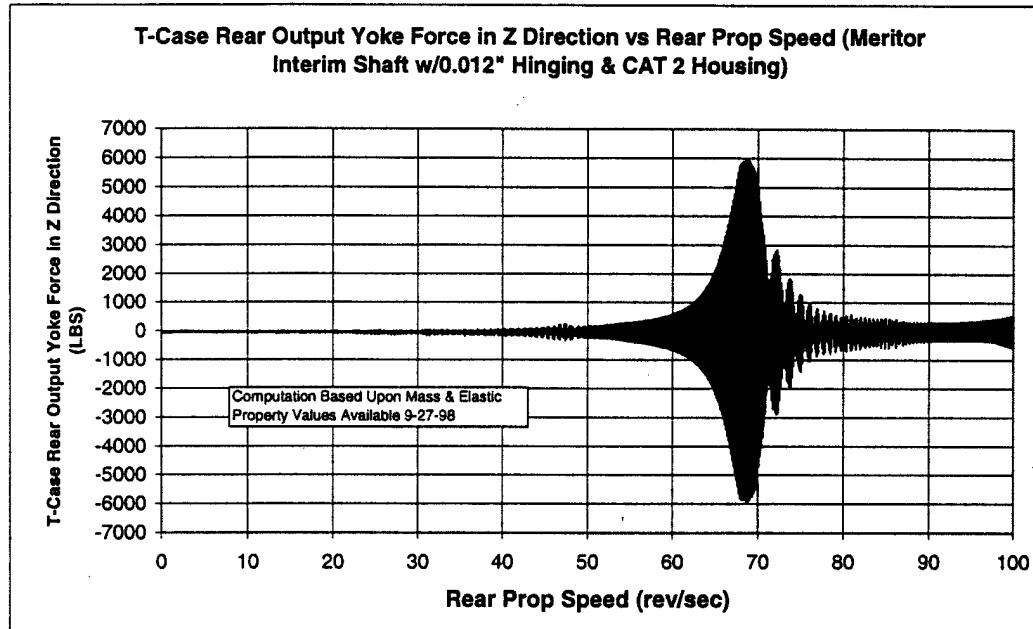
Figure 5.8 MSC DADS model output of Meritor interim driveshaft: similar to original but with a 4" O.D. tube and 3.23" long spline (original production driveshaft hinge stiffness used in model)

Note the model output of the interim driveshaft indicated a resonant frequency of 68-69 Hz. The model output for the Meritor A1 driveshaft is shown in figure 5.9.

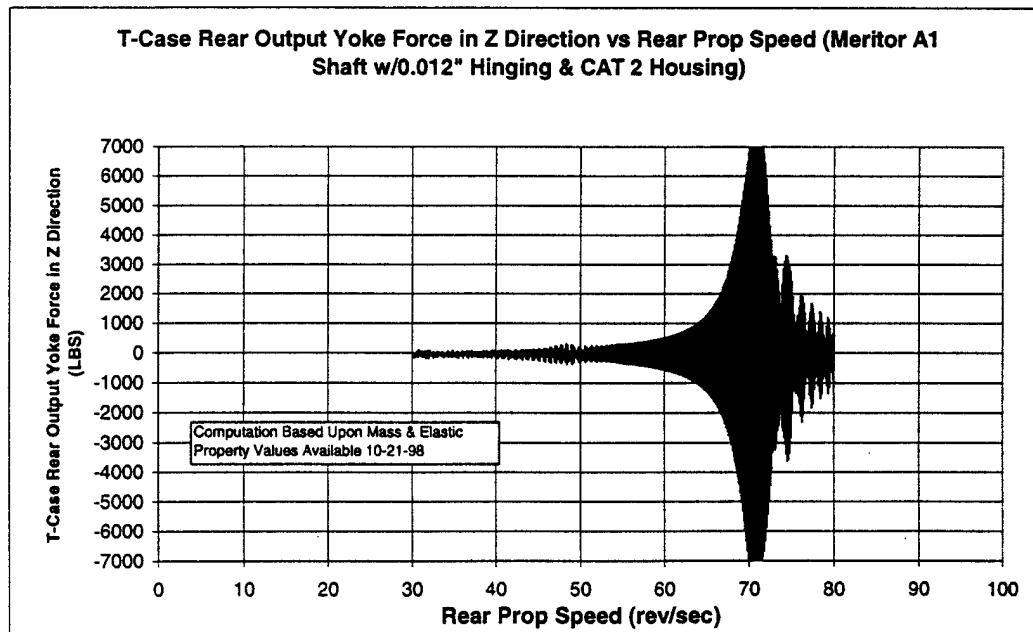
Figure 5.9 MSC DADS model output of Meritor A1 driveshaft: similar to original but with a 4" O.D. tube and 3.85" long spline (A1 measured hinge stiffness used in model)

The A1 driveshaft model indicated a resonant frequency of 70-71 Hz. The measured hinge stiffness for the A1 driveshaft spline section was higher than that measured for the Meritor original production driveshaft. The slight increase in hinge stiffness of the A1 driveshaft was due to the increased engagement length of the slip spline.

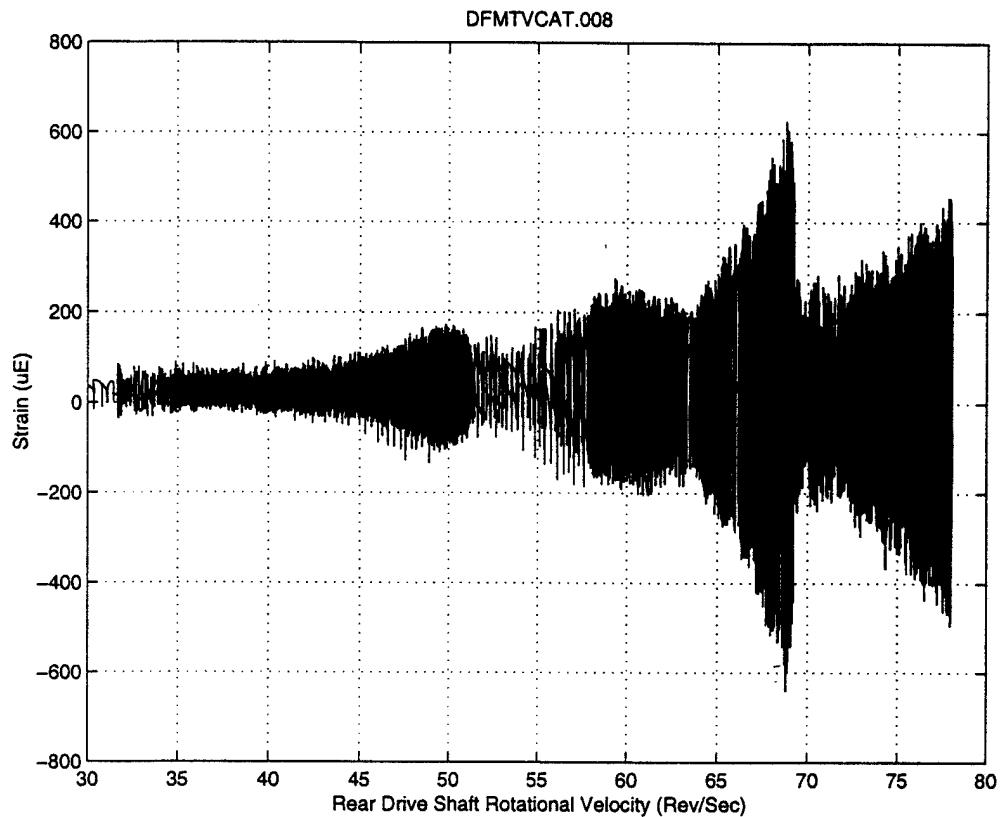
The computed frequency response of the A1 driveshaft model was found to be within 3 percent of the experimentally found frequency resonant response of an A1 driveshaft run through critical as indicated by flywheel housing strains, see figure 5.10.

Figure 5.10 CAT 2 flywheel housing typical strain response with Meritor A1 driveshaft, 30 mph to top speed, front driveshaft grounded, no unbalance added, seventh gear

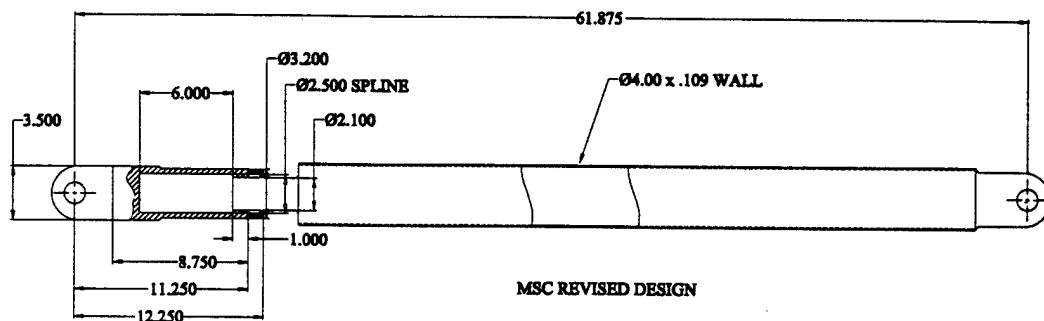
The MSC revised design driveshaft has a less massive 4.00" O.D. X 0.109" wall tube and a 2.5" O.D. spline with 6" of spline engagement. See figure 5.11 for a dimensioned drawing.

Figure 5.11 MSC revised design driveshaft (dimensions in inches)

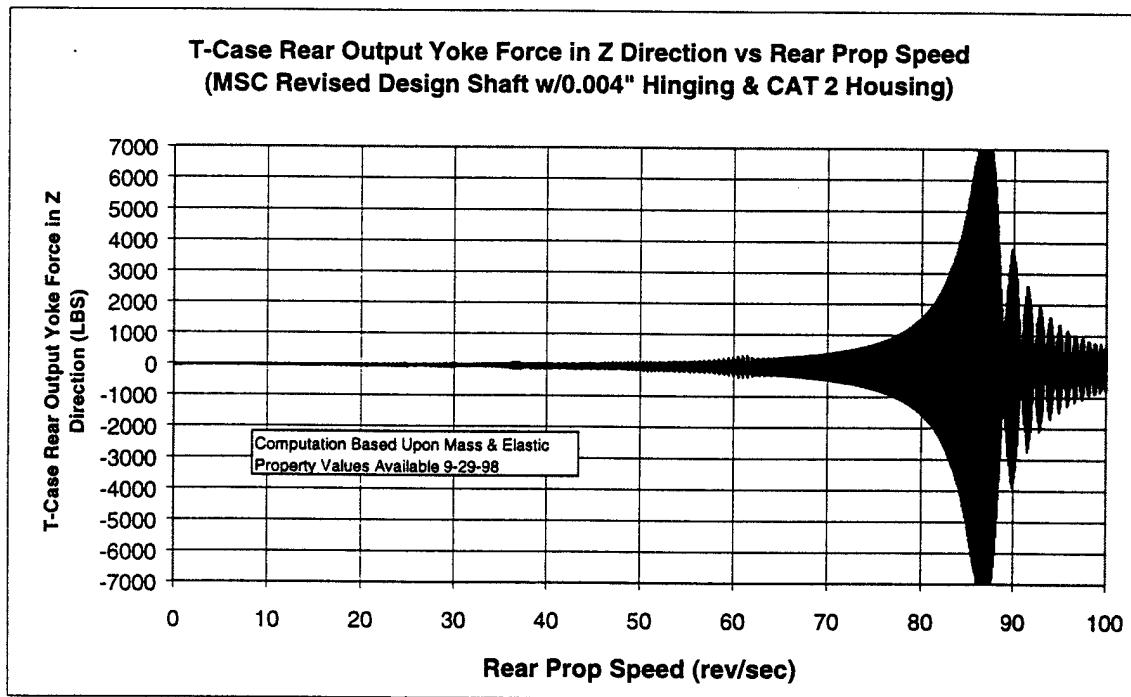
Figure 5.12 MSC DADS model output of MSC revised driveshaft

The MSC DADS model output of the MSC revised design driveshaft indicated a resonant frequency of 86-87 Hz as shown in figure 5.12.

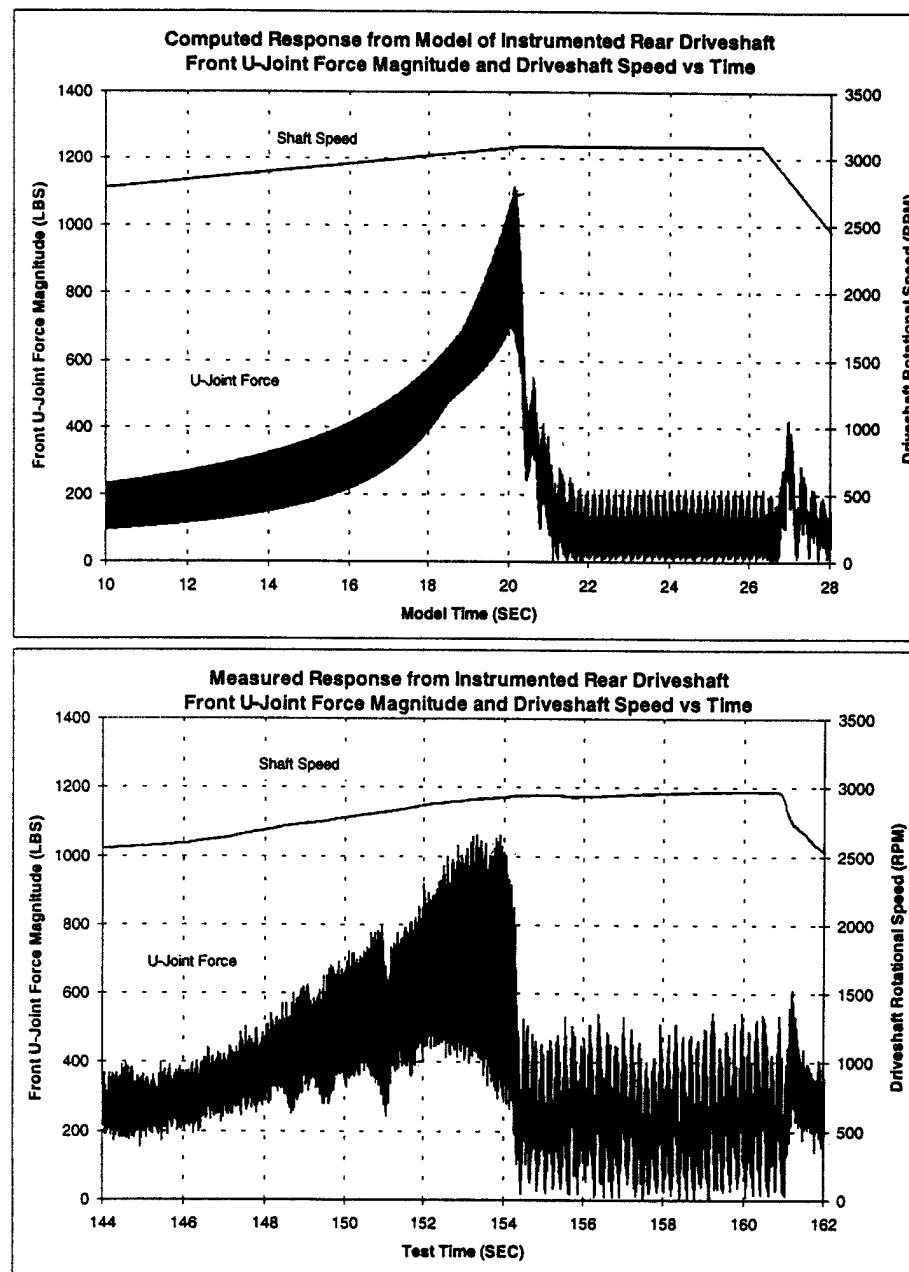
Figure 5.14 Model output vs experimental data for front U-joint force of rear driveshaft

The model results appear to reasonably agree with the experimental data. Note the equivalent maximum force magnitudes of approximately 1000 pounds. These occur at a driveshaft speed of 2900 RPM to 3100 RPM or 48 Hz to 52 Hz, i.e. the critical speed. It is important to understand that the critical speed of the instrumented driveshaft is lowered by the added mass of the instrumentation. As noted above, this mass was also added to the computer model for correlation of computed and measured dynamic responses. Figure 5.15 show the same data in figure 5.14 but with a rescaled time axis so frequency content can be examined more clearly.

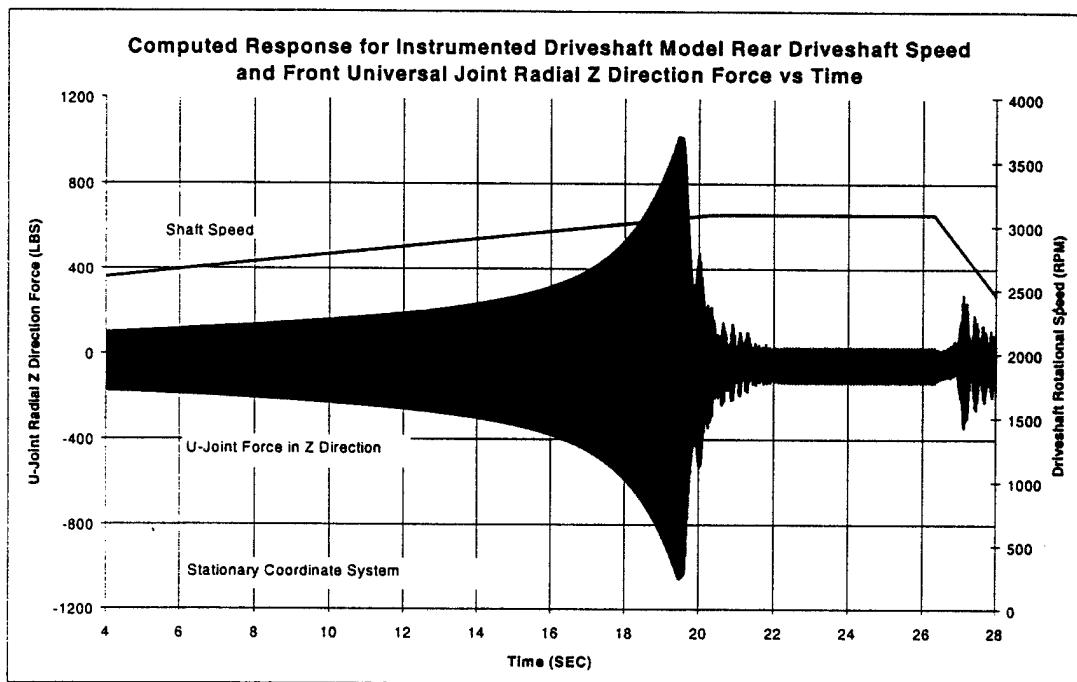
Figure 5.16 MSC DADS model output of U-joint force in Z direction,
instrumented Meritor original production driveshaft

Figure 5.16 shows the model results of U-joint radial z direction force for the instrumented driveshaft. This plot is in the same format as model results of the other driveshafts previously discussed and therefore is useful for comparison.

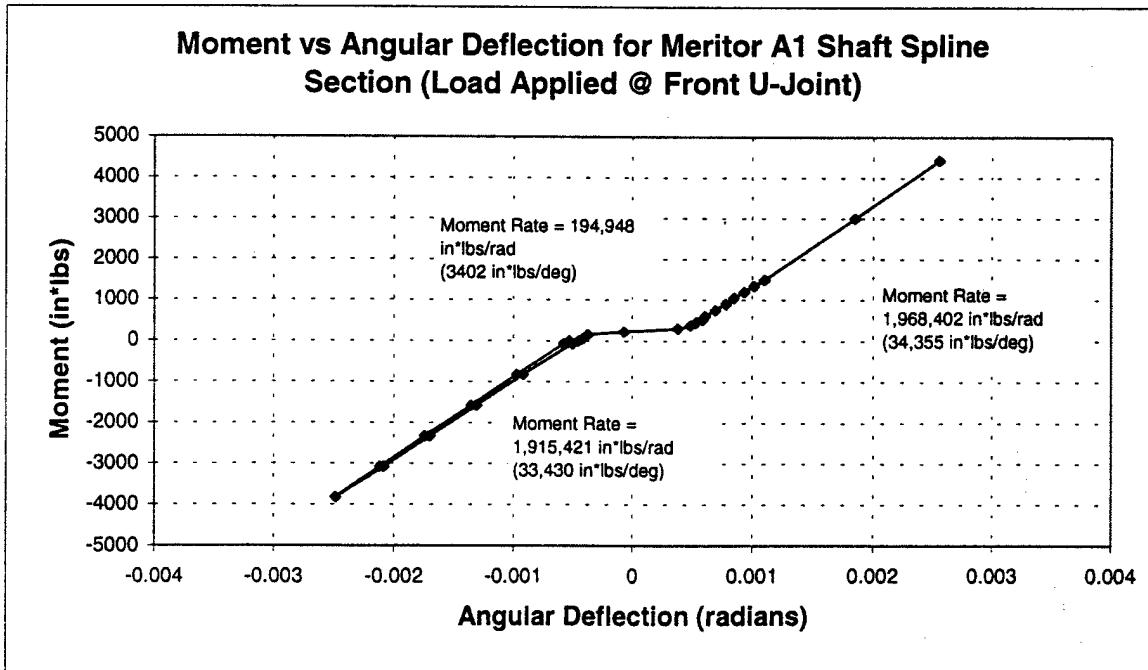
EXPERIMENTAL MEASUREMENTS OF DRIVESHAFT HINGE STIFFNESS FOR MERITOR "ORIGINAL PRODUCTION" AND "A1" DRIVESHAFTS

Note: Original factory shaft had 0.027 inch "hinging"

Note: A1 shaft had 0.007 inch "hinging"

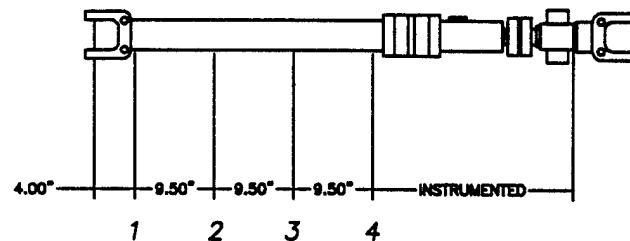
Pre- and Post-test Run-out Measurements of Instrumented Propshaft
Test Vehicle s/n: AT0357B-AC

<u>Pre-test Run-out</u>	
<u>Location</u>	<u>Run-out</u>
(1)	0.0210"
(2)	0.0250"
(3)	0.0335"
(4)	0.0285"

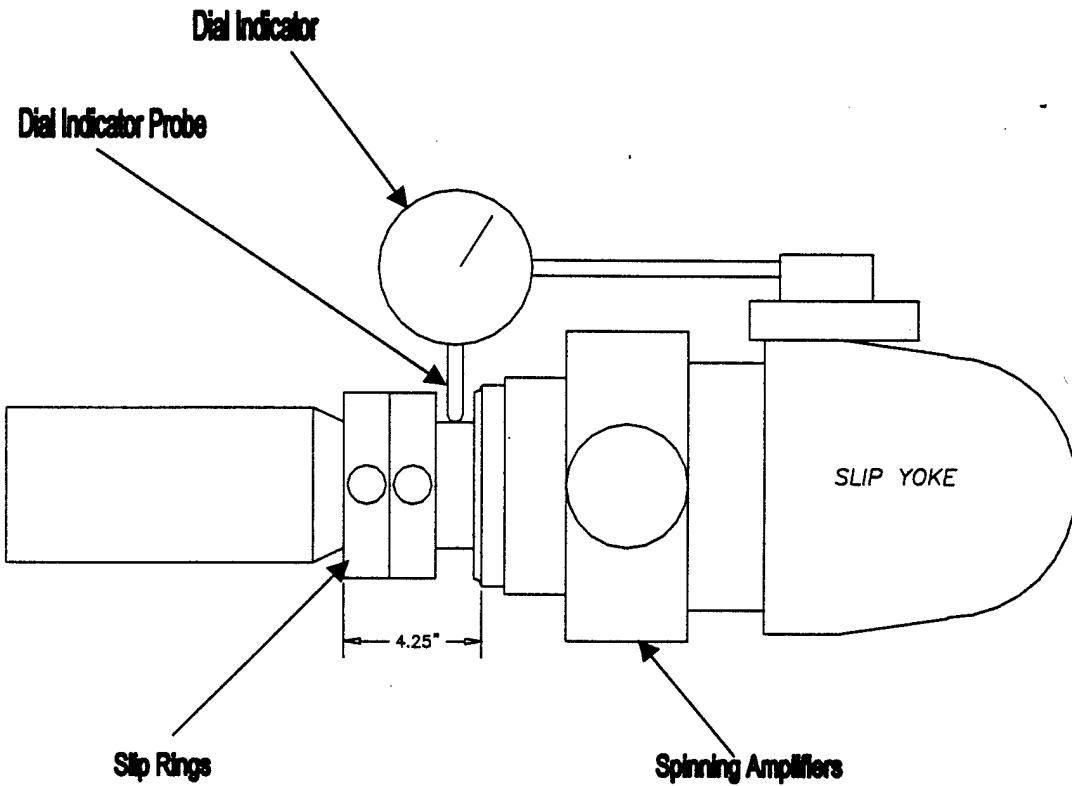
SPLINE JOINT HINGE LASH MEASUREMENT SETUP FOR INSTRUMENTED MERITOR ORIGINAL PRODUCTION DRIVESHAFT (PRE-TEST)

The slip yoke was lifted and a total displacement range of 0.007" as indicated by the dial indicator resulted.
